Project Overview:

- The objective of this project was to redesign a grain bin door to better meet customer needs and increase overall customer satisfaction.
- The deliverables in this project are an easy to latch grain bin door that will not leak small grains, eliminates the presence of moisture, and fixes clearance issues on outer doors.
- The current bin door design has not been updated in over 30 years.
- The problems this project will solve are leaking of the small grains, spoiled grain due to moisture leakage, difficult outer door latch, and clearance issues on the outer doors.

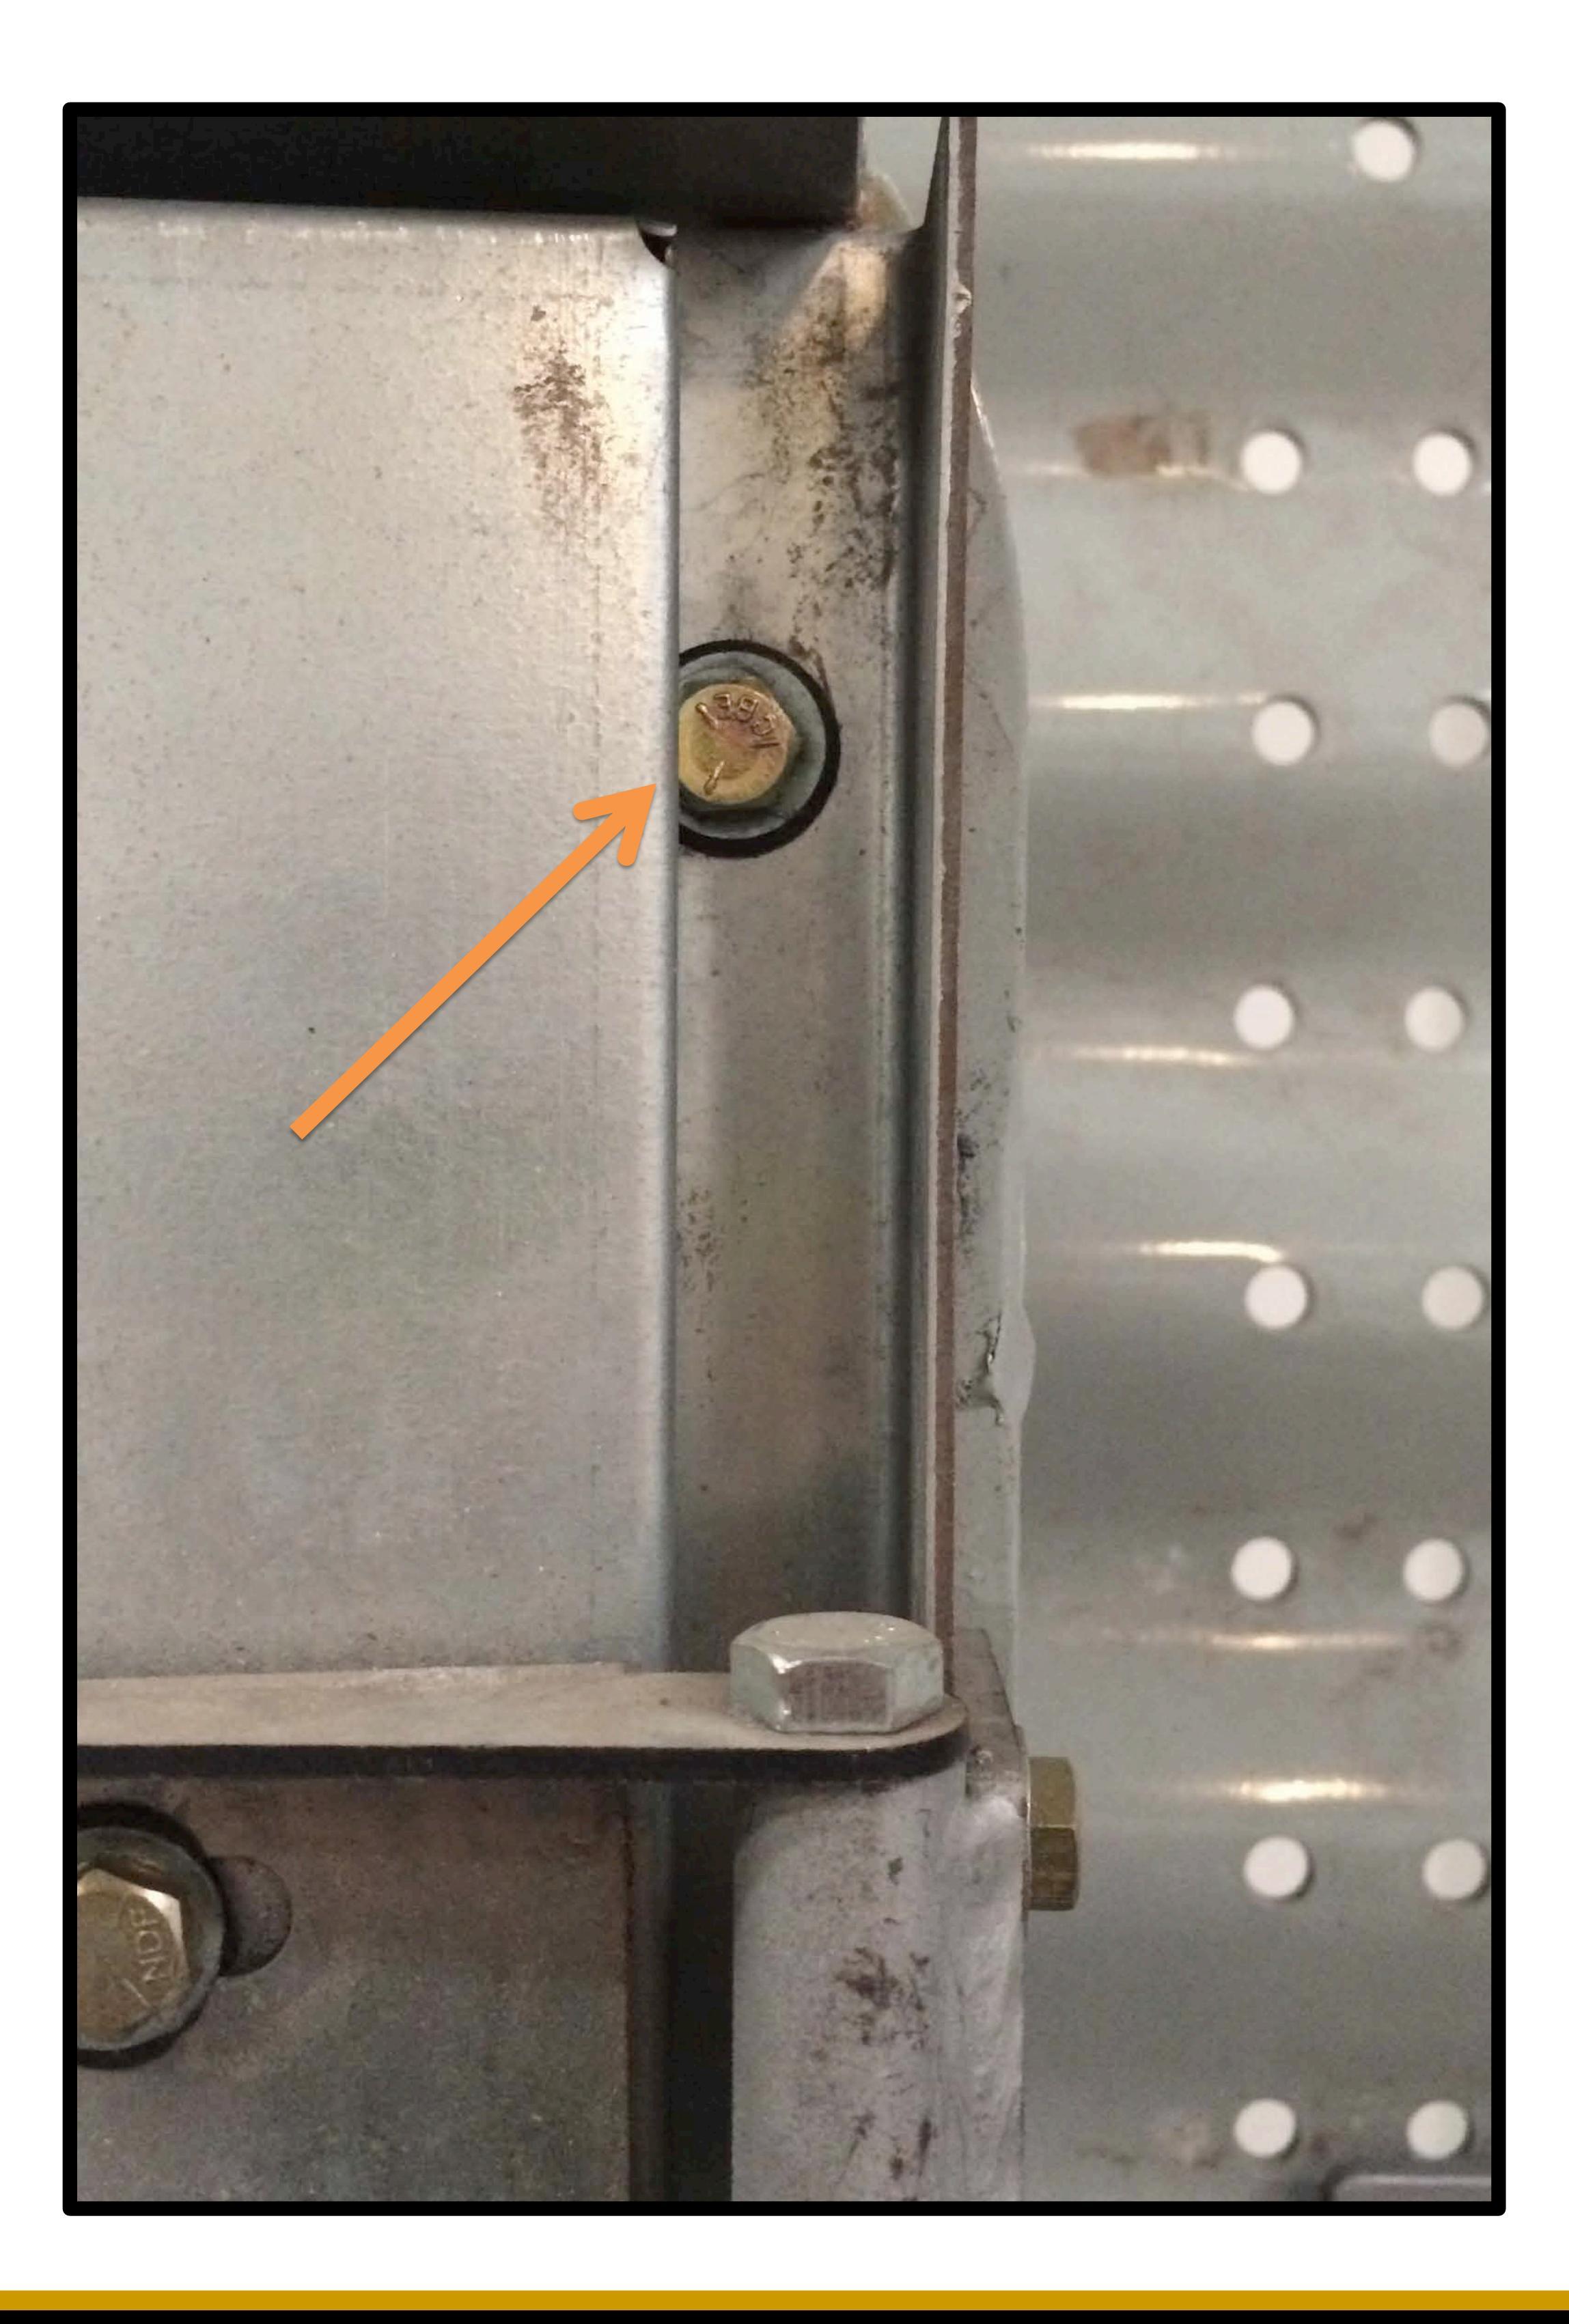
Pictured is a clearance issue with the outer door hitting bolts when closed causing door to be difficult to open/close.

The issue of the outer door clearance issue can be solved by moving the door hinge to the inside of the door frame rather than the outside.

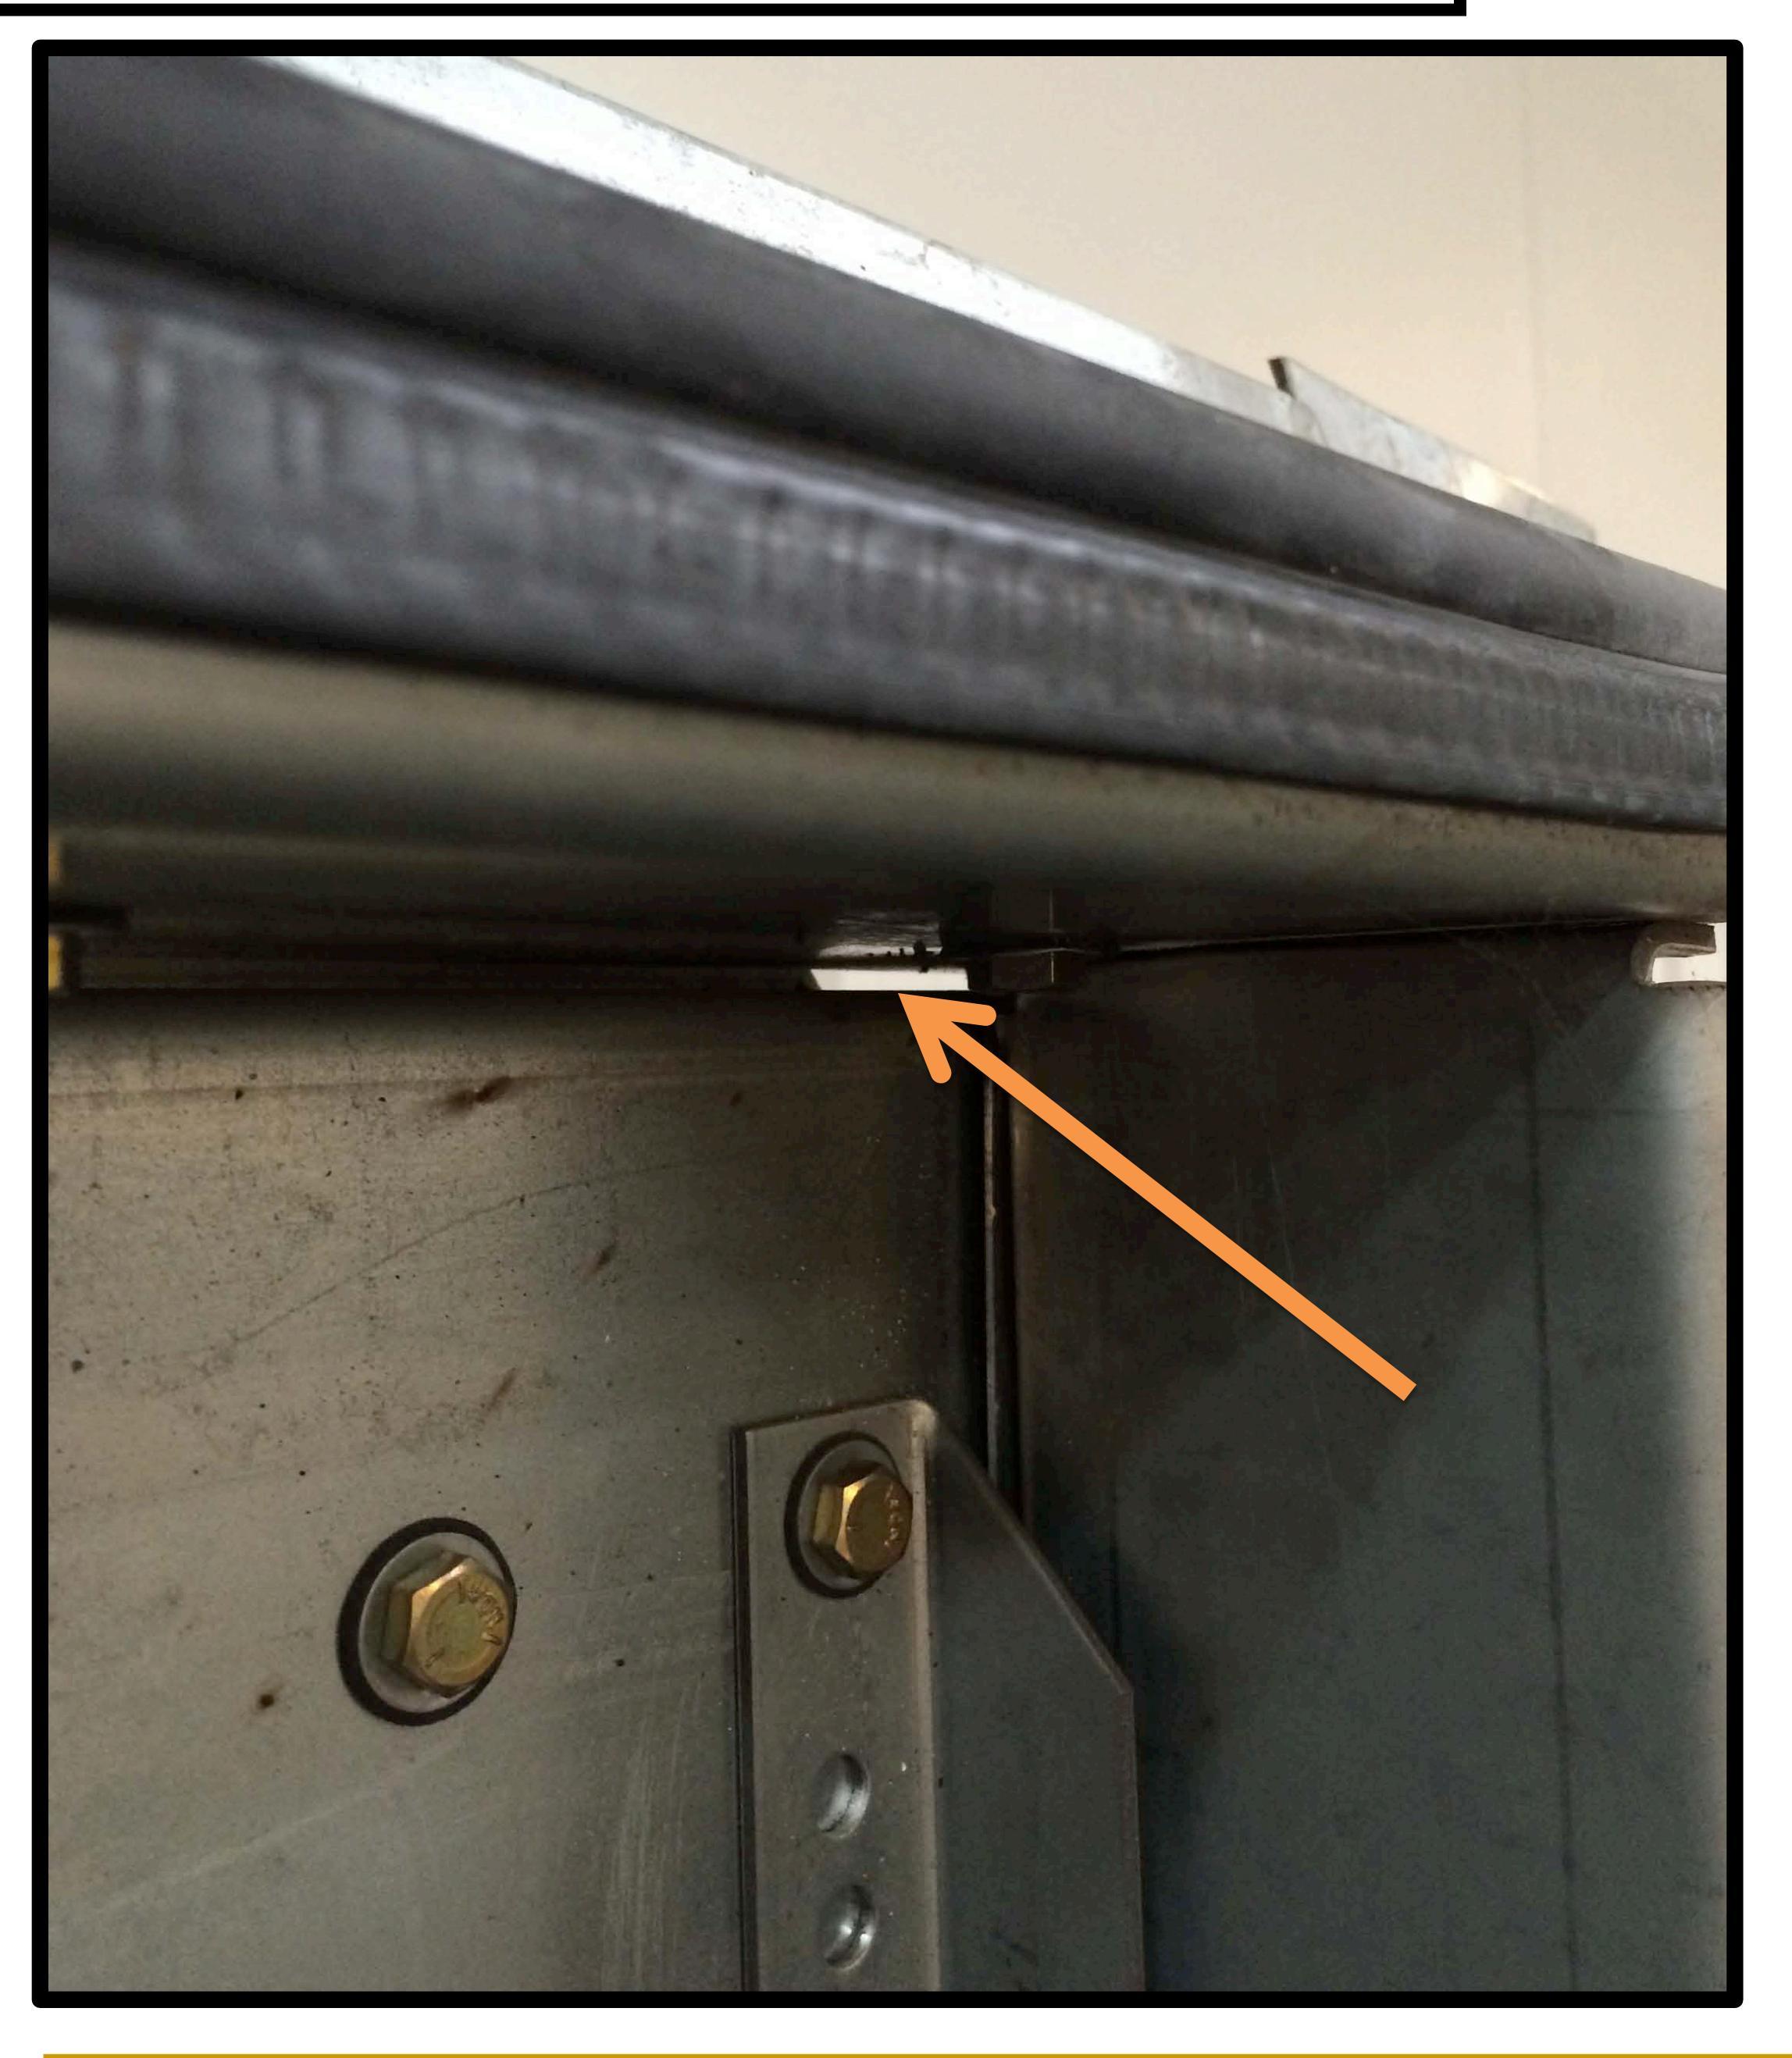
This image shows the problem of small grains (wheat, milo, etc.) leaking from the inner door.

The issue of small grains leaking can be solved by changing the size of the upper inner door, moving the fold up 1/8th inch. Adding weather stripping can also solve the problem.

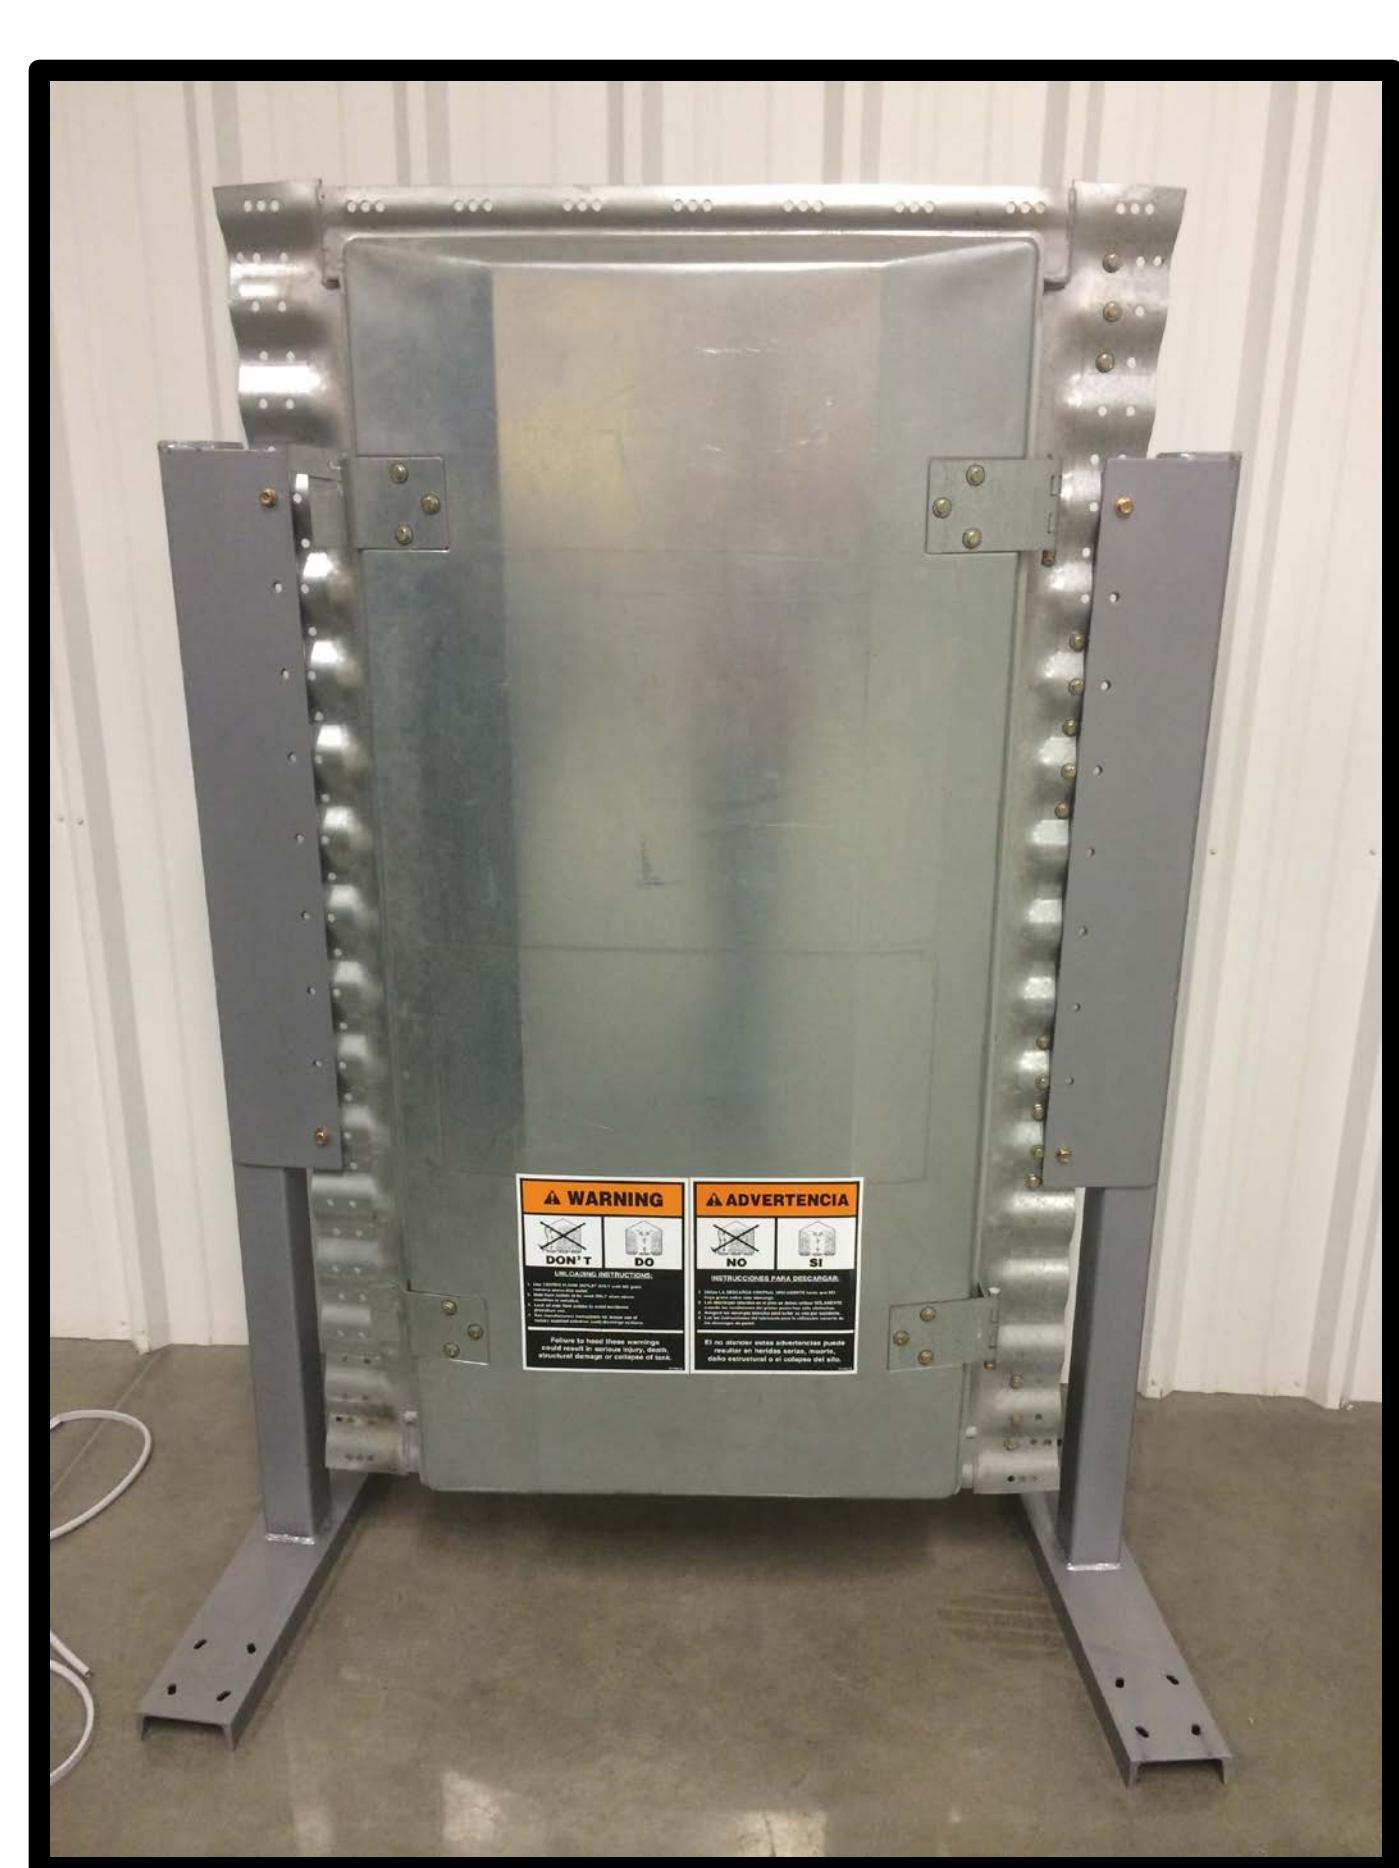
Pictured here is the bin door for bins less than 60,000 bushel capacity.

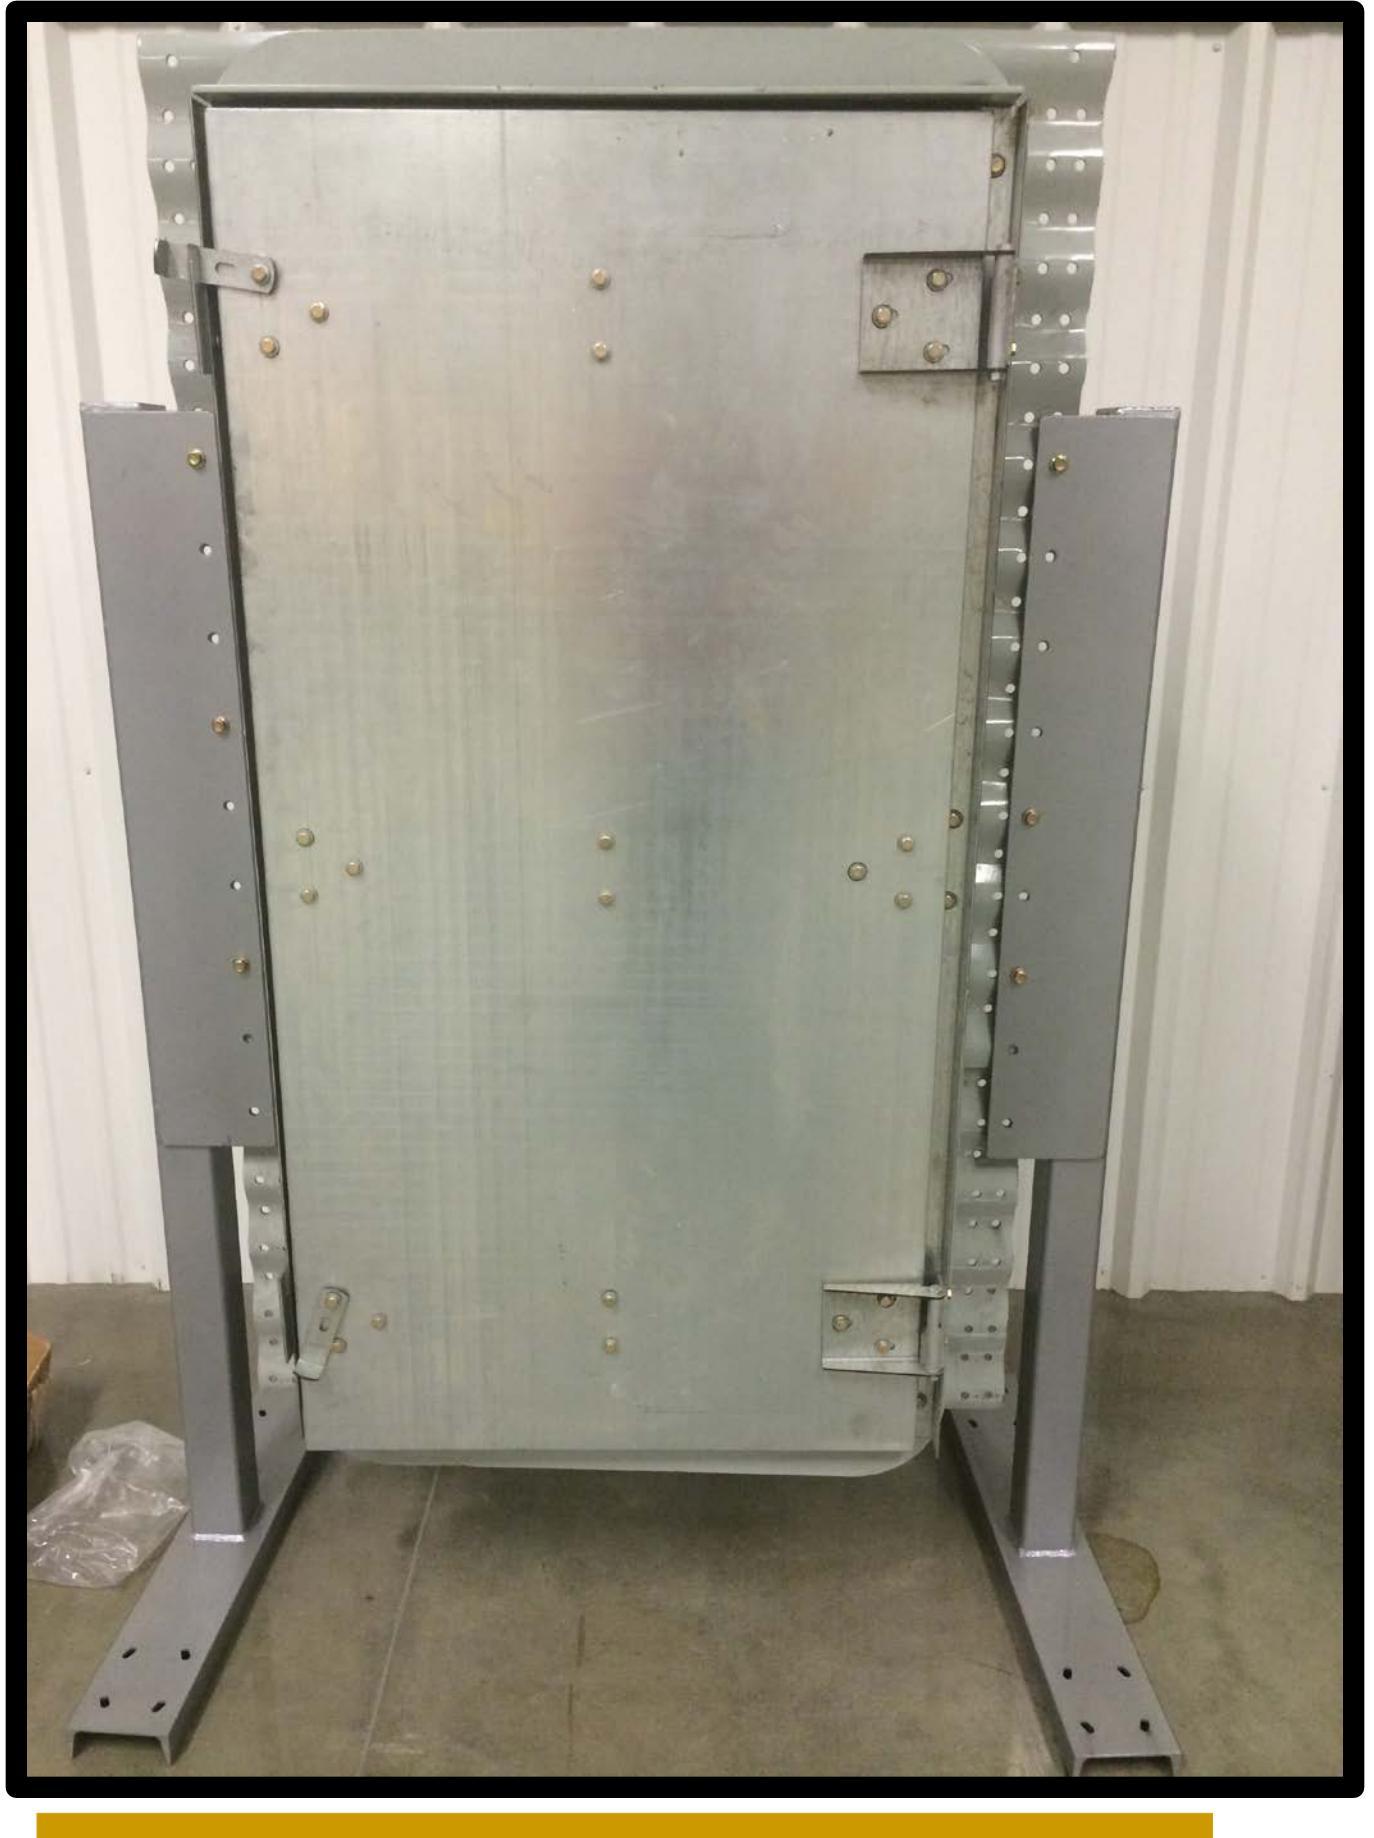
Pictured here is the bin door for bins more than 60,000 bushel capacity.

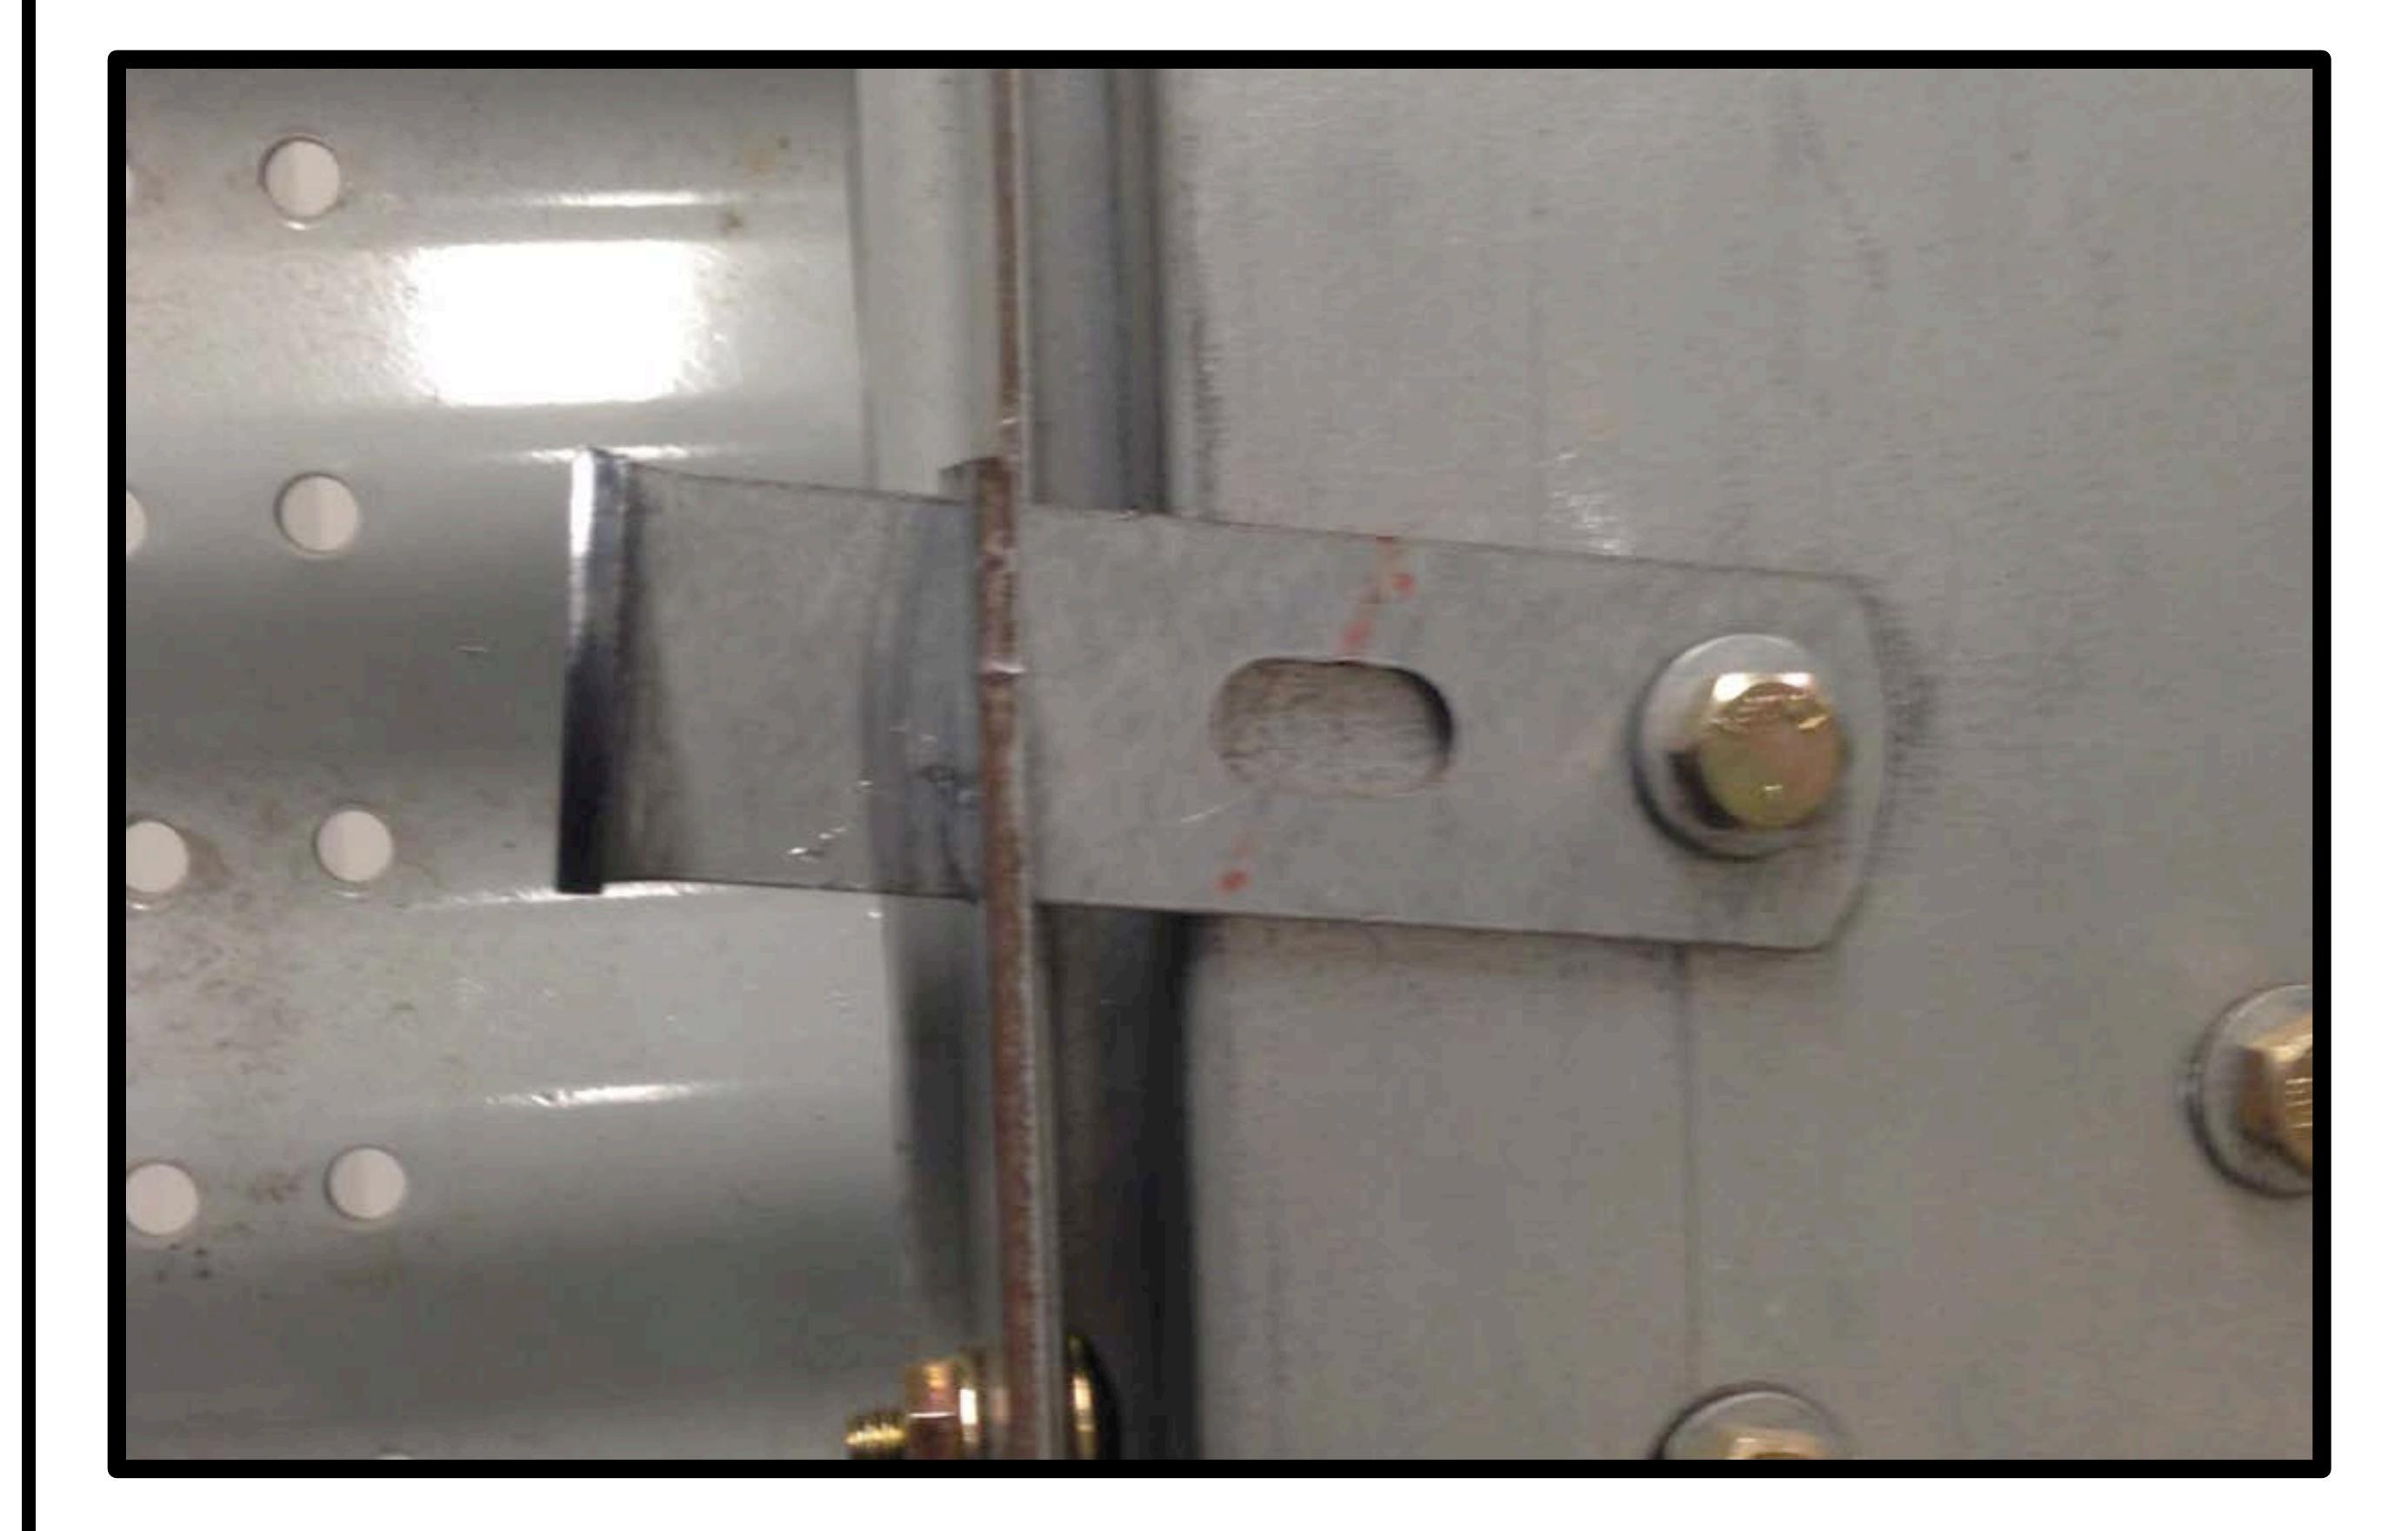
Illustrated here is the current outer door latch design in production from GSI.

The issue of the difficult outer door latch can be solved by installing a pivot and rod door latch with one handle that is easy to open and close.
